# Experimental Dune Restoration and Stabilization, Nauset Beach, Cape Cod, Massachusetts

by  
Paul L. Knutson

TECHNICAL PAPER NO. 80-5

U.S. ARMY, CORPS OF ENGINEERS  
COASTAL ENGINEERING  
RESEARCH CENTER

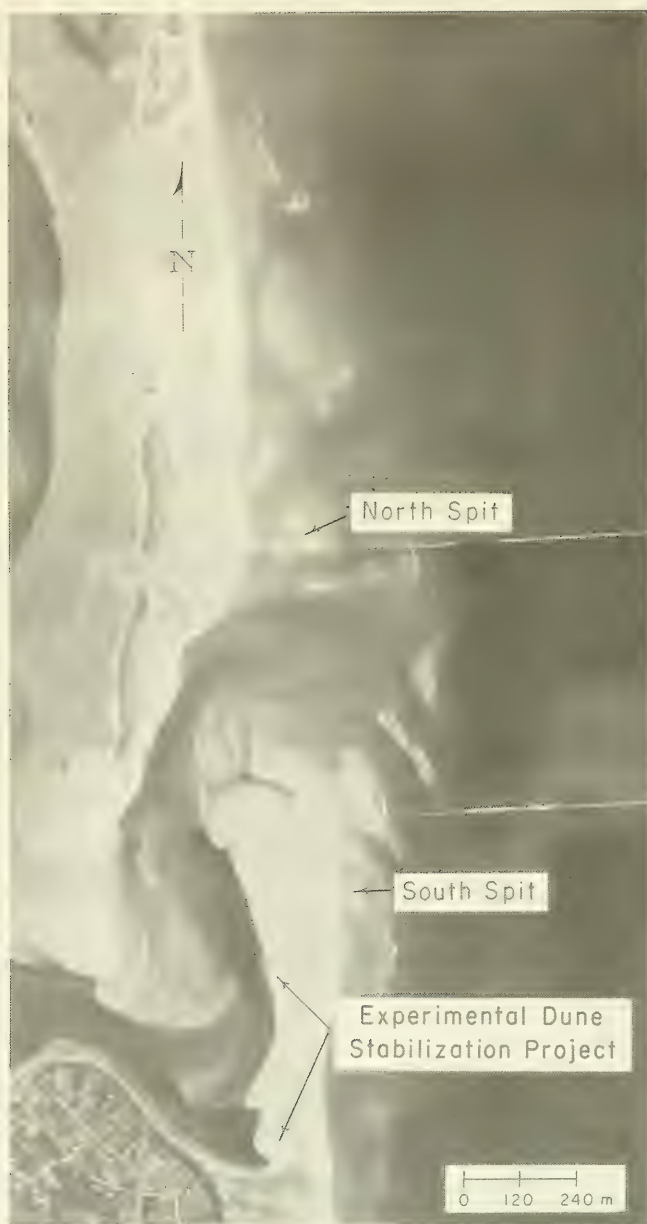
Figure 2. Inlet at Nauset Harbor, October 1969.

From 1856 to 1940 the inlet was located at the south end of the harbor near Nauset Heights. In 1941 the south spit grew northward and the inlet shifted approximately 1.6 kilometers to the north (Zeigler, 1958). Between October 1957 and April 1958, wave action reduced the tip of the south spit from approximately 1,234 to 564 meters (Zeigler, 1958). By 1969, the south spit was approximately 853 meters long, and the inlet was migrating northward.

Field experiments at Nauset Beach were initiated in 1969. Test plots were first established on the Nauset Harbor north spit (Fig. 2). However, during the first year the inlet continued to migrate north obliterating part of the study area (Fig. 3). Since loss of part of the experiment would have negated the study results, the north spit plots were abandoned and new plots were established on the south spit (Fig. 4) in April 1970.

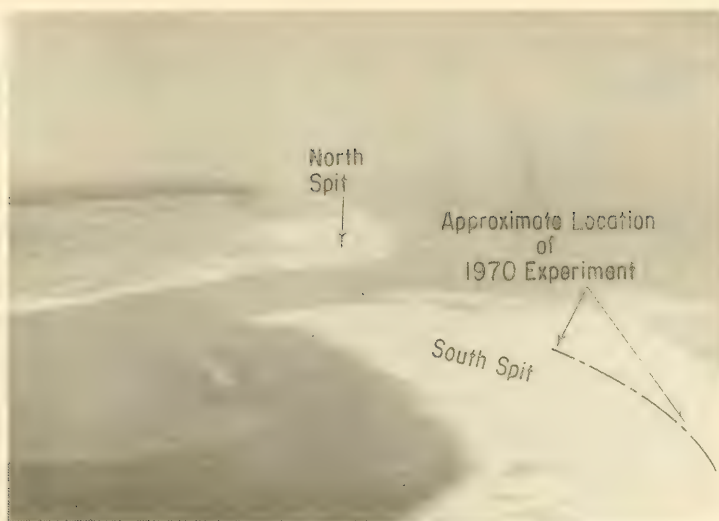
Figure 4. Nauset Harbor (south spit), October 1969.

In April 1970, the south spit was approximately 850 meters long and 180 meters wide. Scattered patches of American beachgrass grew along the landward edge of the spit, extending northward for about 600 meters. The remainder of the spit was unvegetated. Crest elevations along the spit decreased from south to north at a slope of about 1 on 400.

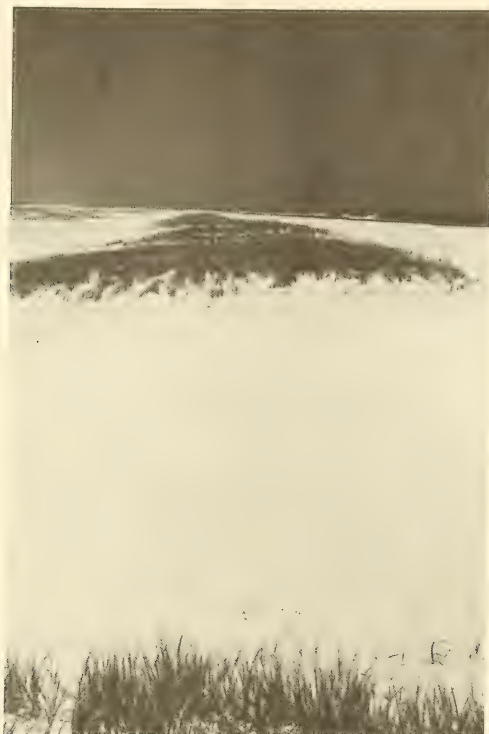
Figure 8. Plot 1 (American beachgrass on 45-centimeter spacing), May 1973.

0.1 meter and sand accumulation was negligible. By October 1972, crest elevation had increased an average of 0.5 meter and sand accumulation was approximately 16.3 cubic meters per meter of beach. Figure 8 is a photo of the plot in May 1973.

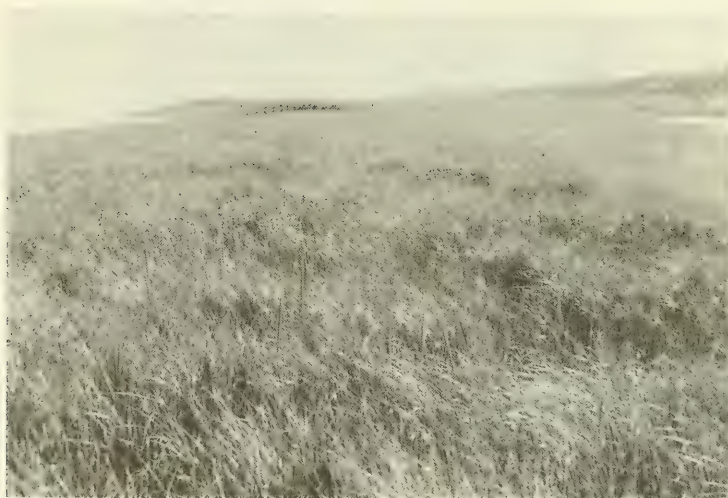
Figure 10. Plot 1 (American beachgrass), October 1977.

c. Long-Term Dune Growth. Growth of the dune at profile line 1 through November 1977, 7 years after planting, is illustrated in Figure 9. Dune width along profile lines 1 and 2 averaged about 61 meters by 1977. The landward and seaward slope along these profile lines averaged 1 on 9.5 and 1 on 15.6, respectively. Dune growth was generally in a seaward direction. The seaward shoreline showed slight accretion until 1973; thereafter, slight erosion returned the shoreline to near its original location. By 1977 the crest elevation had reached 5.5 meters mean sea level (MSL), 1.8 meters above the original planting elevation. Total sand accumulation during seven complete growing seasons was 55 cubic meters per linear meter. Figure 10 is a photo of the plot in October 1977.

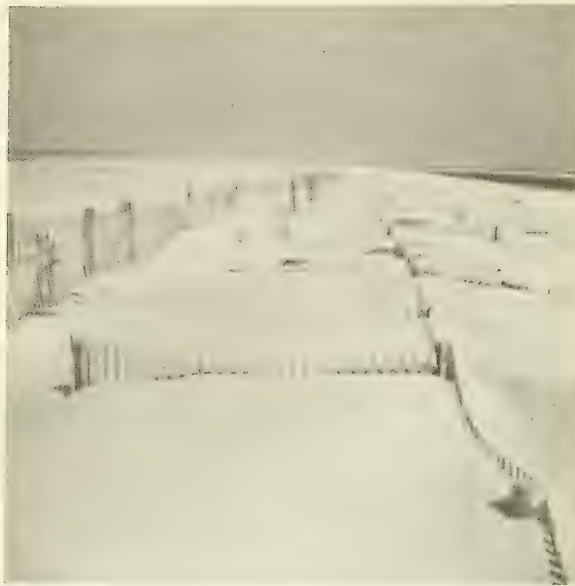
Figure 11. Plot 2 (sand fence with side spurs), March 1971.

b. Short-Term Dune Growth. During the first 8 months, the first lift of fencing accumulated 11.3 cubic meters per linear meter. After 1 year the first two lifts (Fig. 11) had trapped 13.8 cubic meters and after 18 months three lifts had trapped 17.5 cubic meters. Subsequent winter storms, however, removed all accumulated material from the damaged southern section of the plot and removed about 0.9 cubic meter from the northern half. Thirty months (October 1972) after initial installation, an average of 21.3 cubic meters had been trapped by the fences and newly planted (April 1972) beachgrasses.

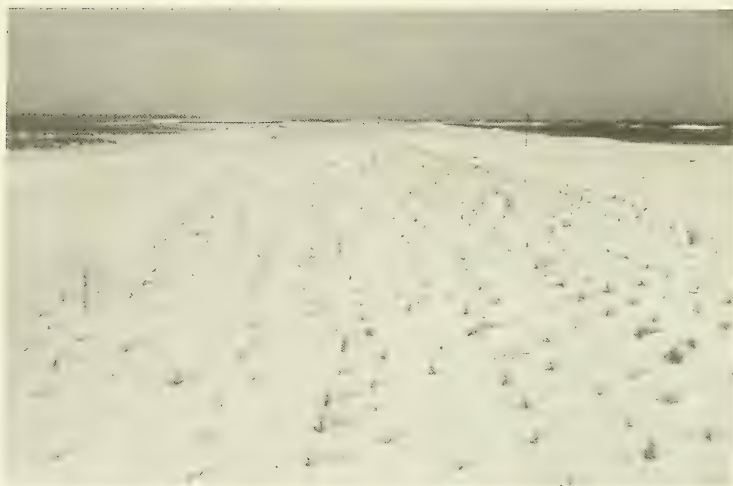
Figure 14. Plot 3 (American beachgrass on 60-centimeter spacing), May 1973; recent planting by local volunteer groups evident.

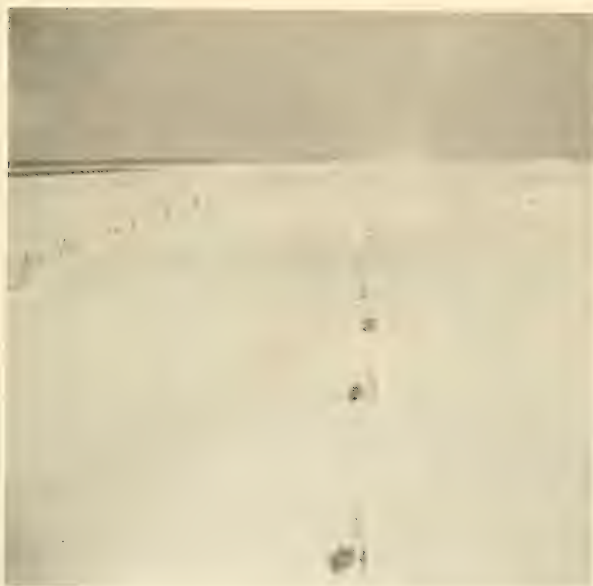
Figure 16. Plot 4 (straight fencing), March 1971.

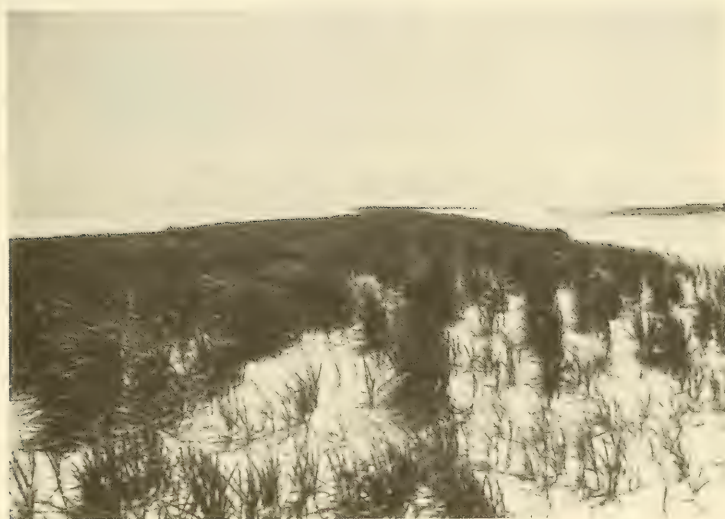
Figure 17. Plot 4 (straight fencing), May 1973.

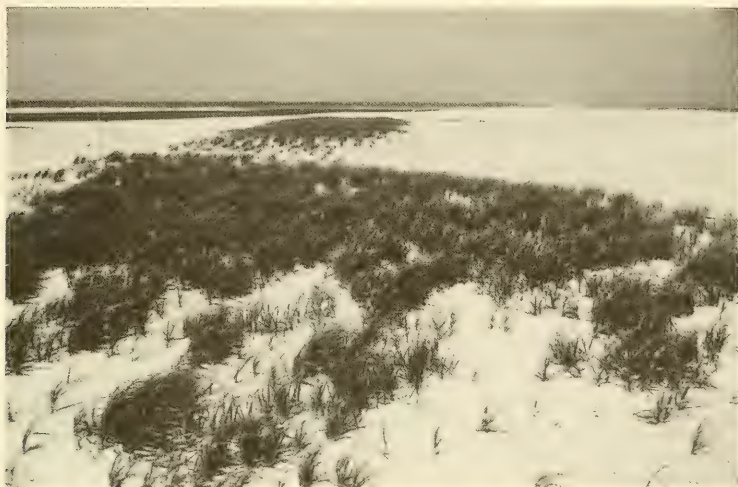
Figure 19. Plot 5 (American beachgrass on 90-centimeter spacing), May 1973.

b. Short-Term Dune Growth. Sand accumulation was negligible at the end of the first growing season. After two growing seasons 10 cubic meters per meter had accumulated and the crest elevation was 2.9 meters, 0.9 meter above the initial planting surface (Fig. 19).

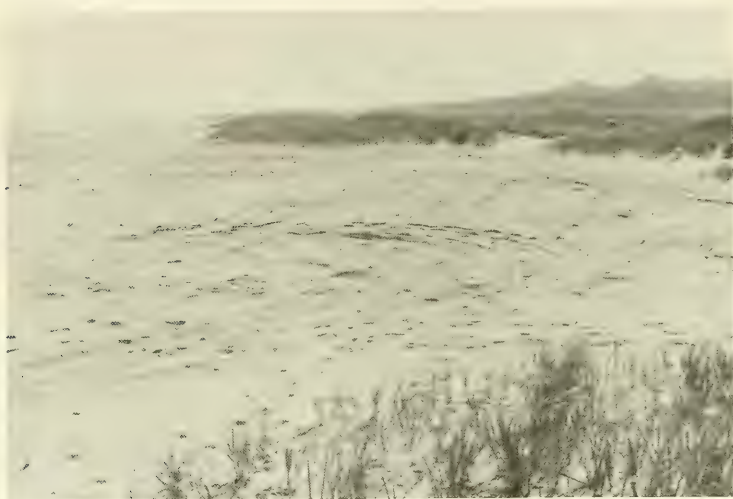
Figure B-2. Plot 3 (American beachgrass on 60-centimeter spacing), October 1977. Note foot and vehicular pathway through plot.

(2) Impact. A field inspection in February 1978 revealed massive erosion on the seaward face of the experimental dunes. Of particular importance, however, is the fact that the plots were overwashed at only one location, the center of plot 3. Plot 3 was bisected by two foot and vehicular thoroughfares that had persisted since 1973. Figure B-2 is a ground photo of plot 3, showing the traffic area, taken in 1977, 4 months before the storm.
